## Shurflo 9300 - Drive Cam Diagnosis

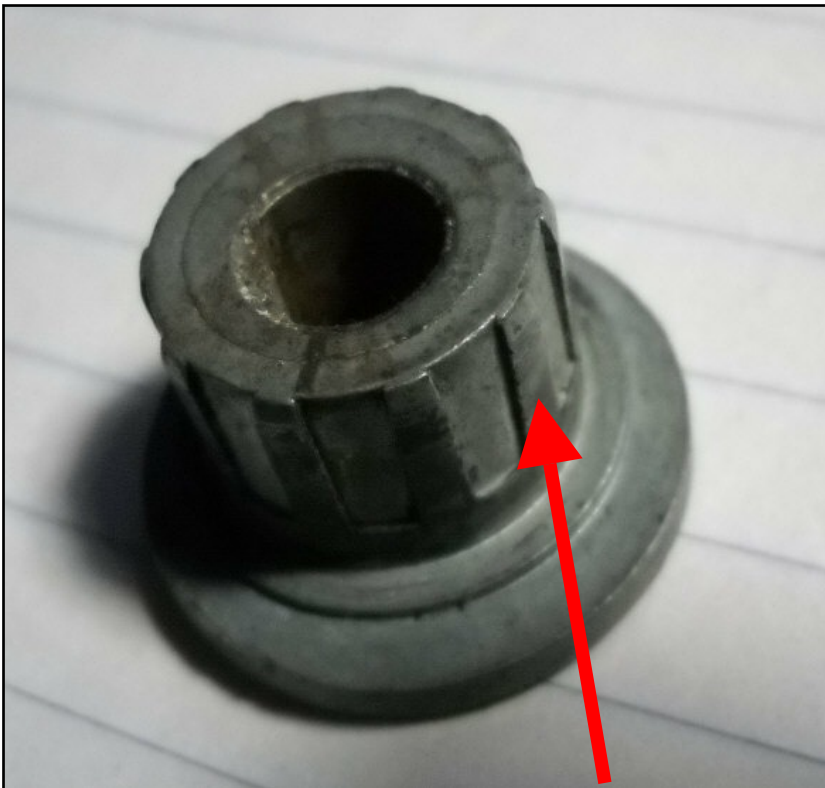
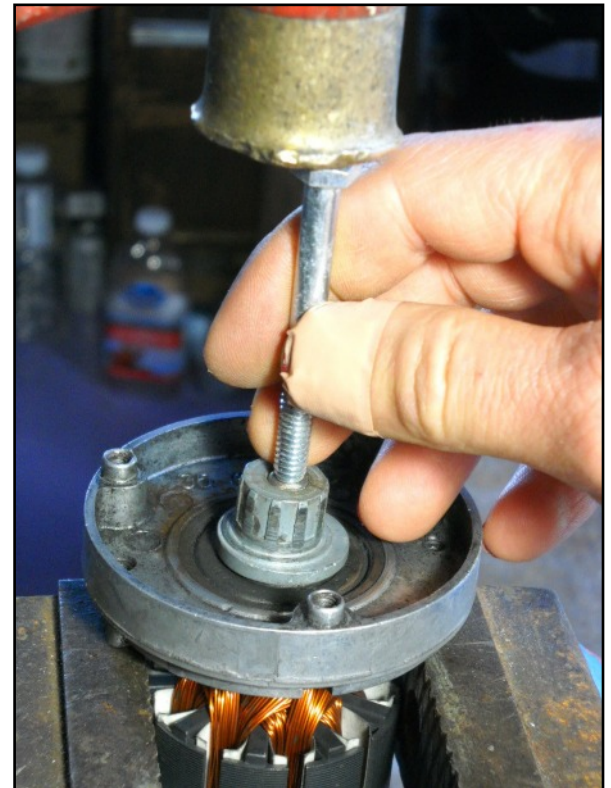
This Drive Cam is in good shape. If the ridges of your Drive Cam are worn off, it can slip in the pump head and cause loss of power to the pump head.

The Drive Cam goes on the motor axle. Check for wear on the outer surface. The ridges should not show wear. If they are smooth, the Drive Cam will slip against the Diaphragm Drive Bearing. Then the motor will run but the pump head will not. Often this part gets stuck on the axle. To remove it, take the motor apart by removing the Brush End Bell and Motor Shell. This leaves the Armature, Front Bearing Assembly and Drive Cam. Put this in a vise that supports the Front Bearing Assembly. Put a bolt on the top of the axle and gently tap the axle out of the Drive Cam with a hammer. Never hammer directly on the axle as that can mushroom the axle making Drive Cam removal very difficult. This part is not available as a separate part from Shurflo, it is included with a new Motor and with Diaphragm/Drive Assemblies.
